Manhole Inspection Summary

Manhole # S27I__017MH

Insp Date: **1/22/09 10:02 AM**

Location Address: **Boyd St.**

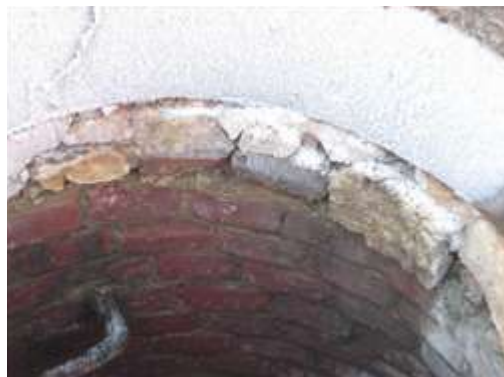
Defect 5

Condition: ☐ Sound ☒ **Cracked** ☐ Root Intrusion ☒ **Loose Brick** ☒ **Deteriorated**

Infiltration: ☐ None ☐ Joint ☒ **Cracks** ☒ **Mortar** ☐ Roots ☐ Wall

chimney deteriorated, cracked, & loose bricks with infiltration from crack & mortar

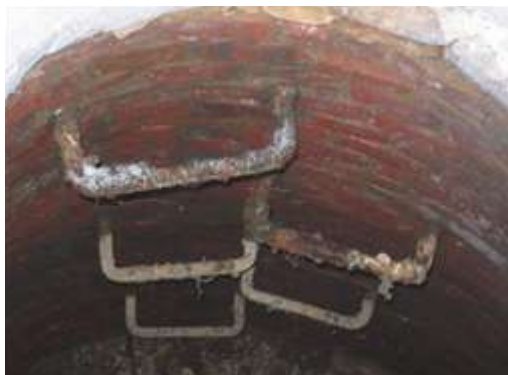
Defect 6

Count: **5** Missing: **0** ☒ **Corroded**

corroded rungs

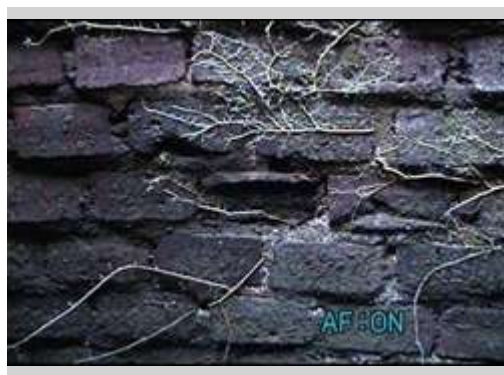
Defect 1

Condition: ☐ Sound ☐ Cracked ☒ **Root Intrusion** ☒ **Loose Brick** ☒ **Deteriorated**

Infiltration: ☐ None ☐ Joint ☒ **Cracks** ☐ Mortar ☒ **Roots** ☒ **Wall**

corbel has loose brick, roots, & is deteriorated with infiltration from roots & wall

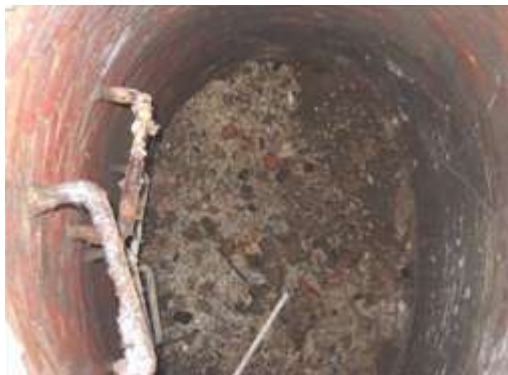
Defect 2

Condition: ☐ Sound ☐ Cracked ☐ Root Intrusion ☐ Deteriorated ☐ Leaks ☒ **Debris**

channel debris
